## APPENDIX 5 – referring to chapter 5 “Examples of interesting findings from real incident information”

### 5.1. EVALUATION OF QUESTIONNAIRES ON REAL TUNNEL INCIDENTS – SURVEY OF 32 REAL TUNNEL INCIDENTS

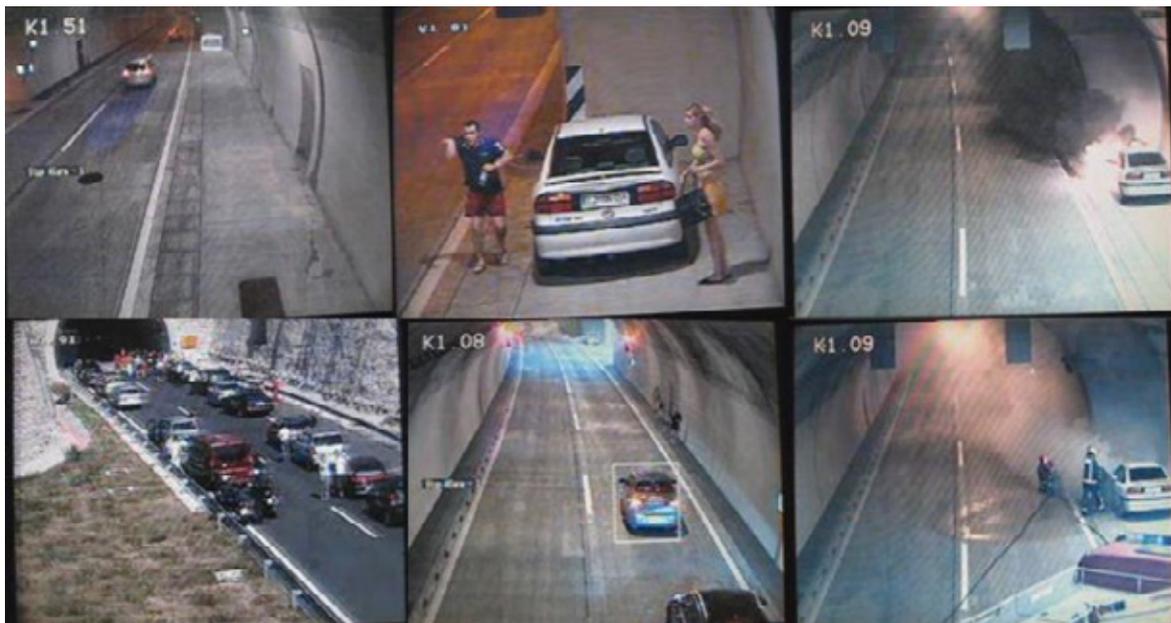
**Short description of incident:** Self-ignition of a car stopped in lay-by

MAINS CONCLUSIONS	
<b>Human behaviour</b>	Driver + accompanying person leave their car - they do not know how to behave They moved on walkway away from lay-by Some cars stopped in right lane next to them Cars did not respect red light at tunnel portal for quite some time Dangerous movements of vehicles in front of portal have been observed (U-turn etc.) Finally the 2 people left the tube through an emergency exit
<b>Emergency Services</b>	-
<b>Tunnel Equipment &amp; Operation</b>	Smoke coming out of tunnel portal is sucked into non incident tube (ventilation mode: fans blowing into tunnel from both sides to produce overpressure) → It is intended to change the ventilation mode in non-affected tube (in both tubes the airflow should be in the same direction)

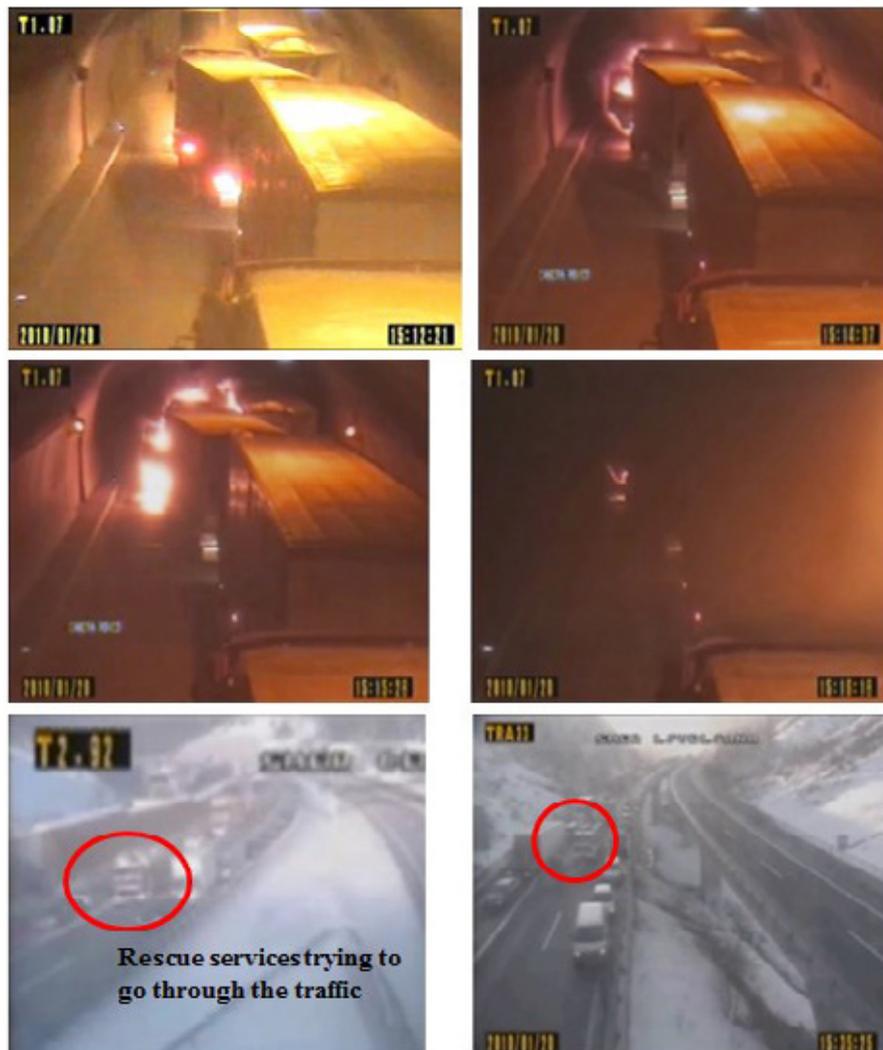
- Example 2:** Rear end collision with fire as a consequence
- Short description of incident:**
- Unexpected stop of HGV; Second & Third HGVs crash into it. 8 lorries involved, partly crashed.
  - Fire started immediately - estimated fire size: 15-20MW
  - Dense traffic

<p><b>Human behaviour</b></p>	<p>One driver ran in direction of air flow                  Some stayed in cabins                  Some vehicles drove backwards                  No vehicles passed fire site                  Drivers respected red light almost immediately (no barriers)                  Only 2 drivers used emergency exits (only when they felt threatened by smoke, even though an emergency exit was very close). The evacuation of other drivers (the ones that remained in their vehicles at first) was organized by one active driver.</p>
<p><b>Emergency Services</b></p>	<p>Emergency services had difficulties to approach the incident due to congestion up to tunnel portals</p>
<p><b>Tunnel Equipment &amp; Operation</b></p>	<p>After 3 minutes, piston effect decayed: longitudinal airflow stopped and turned to be negative                  Longitudinal ventilation was only activated after 12 minutes (3m/s)                  There was clear stratification of smoke almost all the time                  → Algorithm for emergency ventilation will be changed as a consequence of the event</p>

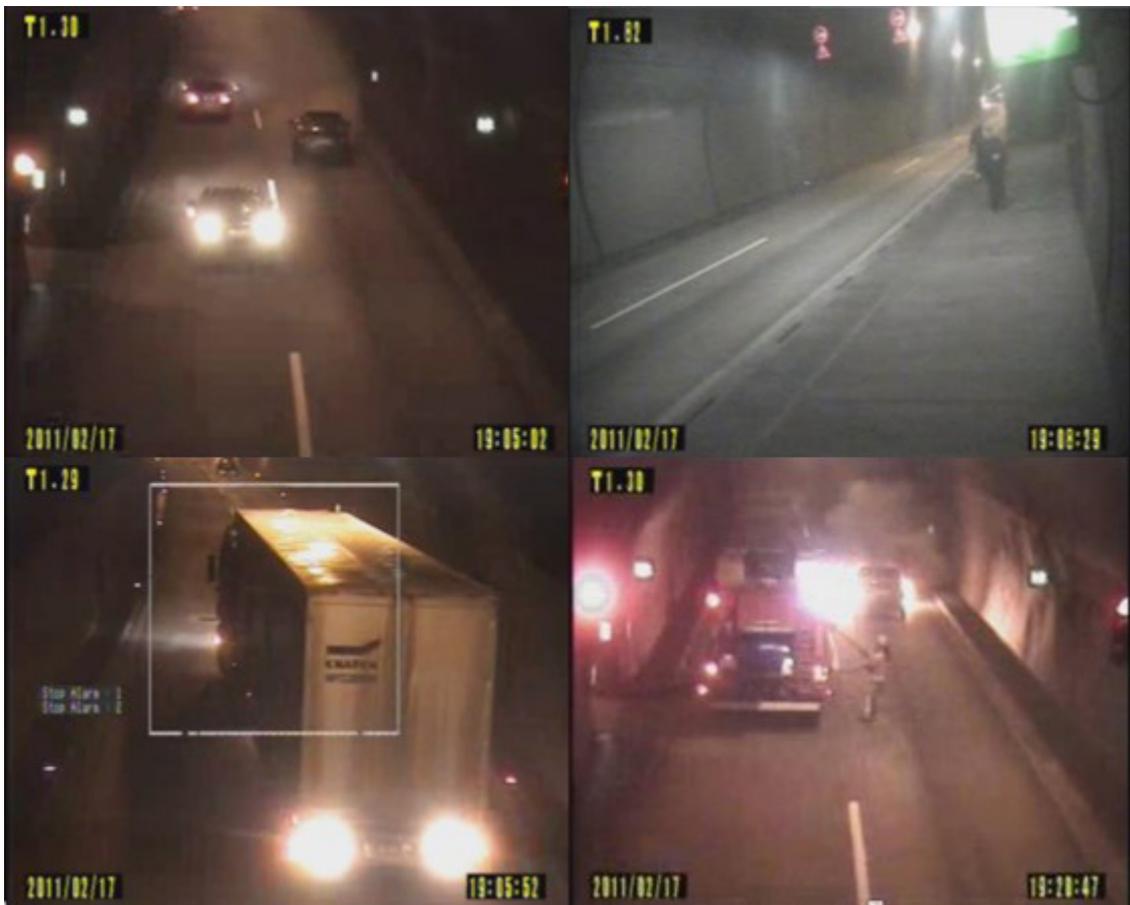
**Short description of incident:** Combi-vehicle stopped and started burning 730 m after portal

MAINS CONCLUSIONS	
<b>Human behaviour</b>	All cars passed by. One car stopped and helped to extinguish without success. Red light was respected quickly.
<b>Emergency Services</b>	Operator started ventilation as soon as he noticed back layering. Fire brigade extinguished fire quickly. Approach was easy (“ <i>emergency-access-lane</i> ” was respected)
<b>Tunnel Equipment &amp; Operation</b>	Radio systems of police & emergency services are not compatible

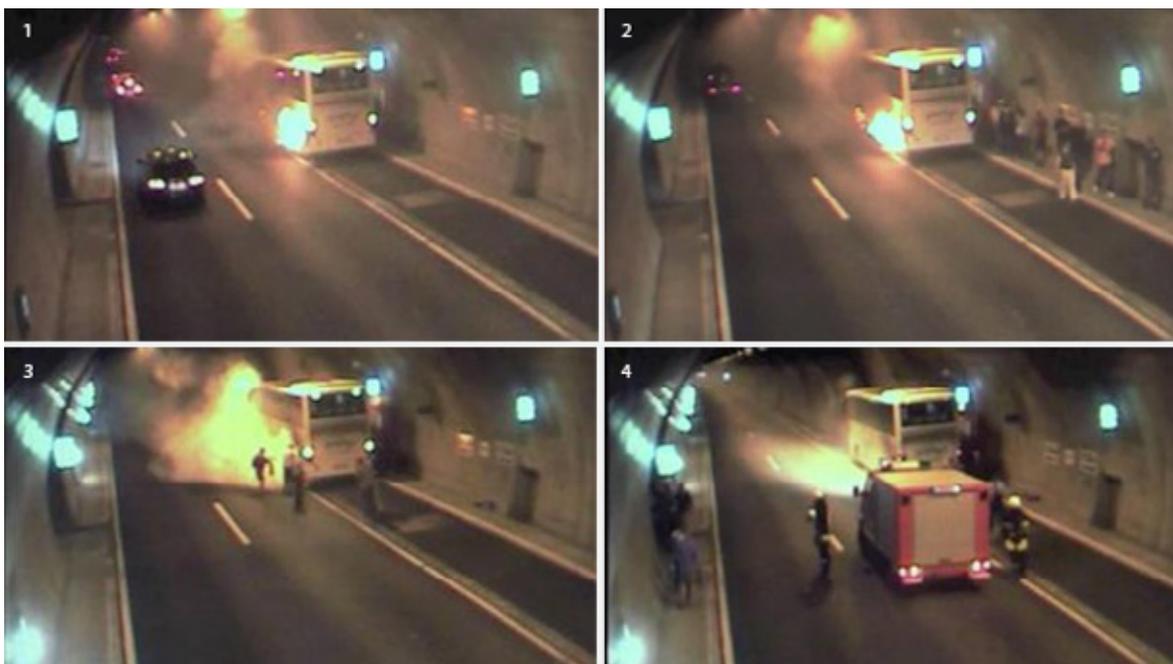
**Short description of incident:** During the day on a motorway with normal traffic conditions, a bus caught fire due to a technical fault. More than 20 persons were involved. No injury. The incident was detected by the control centre via visibility meter alarm and a loop in lay by. Both tubes were closed to traffic immediately after the detection.

<p><b>Human behaviour</b></p>	<p>Very good behaviour of bus driver and tour guide:</p> <ul style="list-style-type: none"> <li>- Bus stopped in the nearest lay by</li> <li>- Bus passengers evacuated the bus to the next emergency exit</li> <li>- Use of fire alarm (push button repeater at emergency call cabin)</li> <li>- Use of fire extinguishers</li> </ul> <p>However, emergency call cabin were not used</p> <p>Approx. 80% of drivers passed by. The rest (approx. 20 vehicles) stopped in front of the accident and evacuated via the next emergency exits (after order via FM-broadcast). Barriers and red lights were respected.</p>
<p><b>Emergency Services</b></p>	<ul style="list-style-type: none"> <li>- very fast arrival of fire fighters at scene</li> <li>- Fire fighter in charge could not be recognized by tunnel users</li> <li>- Fire fighters forgot to ask the bus driver about the number of passengers in the bus</li> <li>- They used technical terms not understandable by tunnel users</li> <li>- Emergency service staff should be marked with name badges or something similar (in case of further inquiry)</li> </ul> <p>After this intervention, operative rules for fire fighters were adapted: they are now requested to interview tunnel users and especially bus drivers and tour guides if any.</p>

<p><b>Tunnel Equipment &amp; Operation</b></p>	<p>To have a sufficient number of fire extinguishers was very helpful.</p> <p>Problems have been experienced due to different types of fire extinguishers with different release functions → Same types of fire extinguishers now.</p> <p>Push button repeater at emergency call cabin was very easy to recognize.</p> <p>Loud speaker announcements were not understandable due to high noise level in the tunnel (ventilation) → a new loudspeaker system has been installed.</p> <p>Due to the shadow of the bus there was difficulty in recognising the exit.</p>

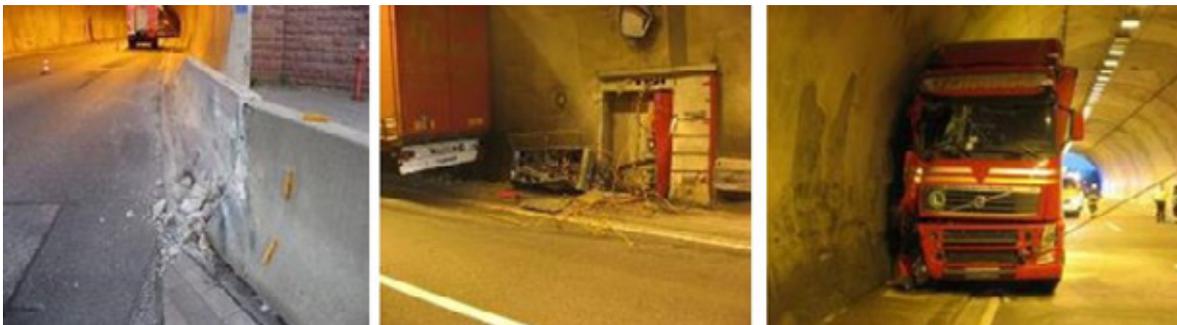
Due to inattention of the driver (micro sleep), the lorry hit an emergency call cabin and damaged the crash barriers in front of the tunnel.

<b>Human behaviour</b>	All other vehicles already in the tube passed by After tunnel closure (the accident was detected in the control centre thanks to a message error of damaged tunnel equipment, and the tunnel has been closed immediately), no one entered the tunnel: barriers and red lights were respected. The lorry driver called the police via his cell phone.
<b>Emergency Services</b>	Quick arrival of emergency services at the scene. No problem reported.
<b>Tunnel Equipment &amp; Operation</b>	Damage to CCTV camera / emergency call cabin → several error messages/alarms were generated in the tunnel control centre → very fast detection by the Operator. Vibration strips in the road surface should normally help to prevent this kind of accident. After the tunnel tube was reopened again one lane was closed for a longer period for repair works at the damaged tunnel equipment (Emergency call cabin).

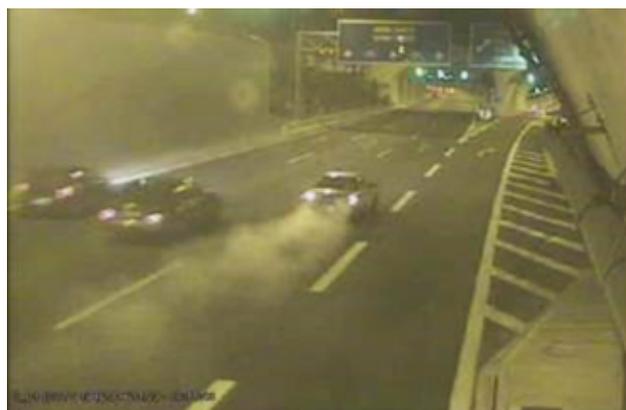
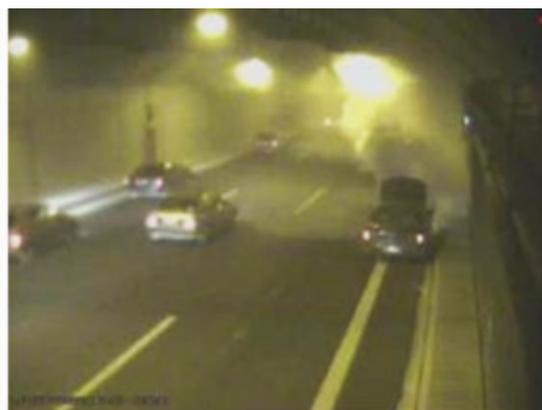
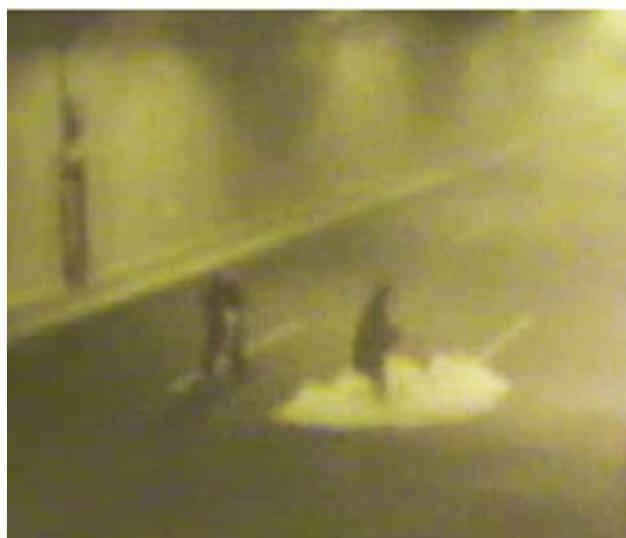
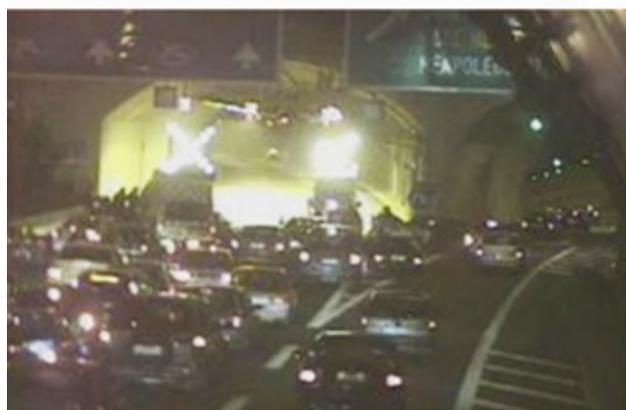
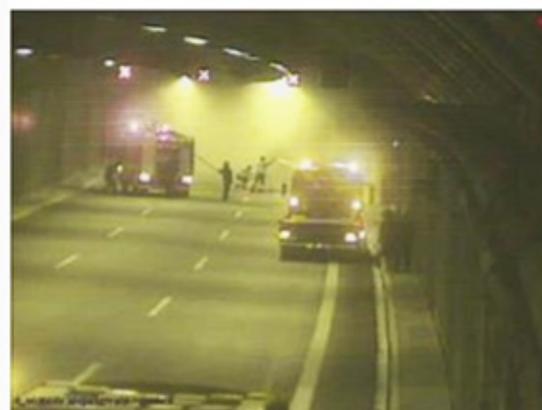
**Short description of incident:** Already on fire, a vehicle entered an urban motorway 2 tubes tunnel (driver had not realized the fire); then stopped inside the tunnel as the fire grew rapidly. The vehicle was followed by a patrol car of the operator, whose patroller tried ineffectively to alert the driver. The patrol car stopped at the entrance of the tunnel where patroller proceeded to block the entry of other vehicles into the tunnel (the traffic was deviated onto the adjacent motorway exit) while alerting the control centre.

<b>Human behaviour</b>	<p>The driver remained on site throughout the incident.</p> <p>Some other car drivers stopped to assist (use of emergency phone to alert the control centre &amp; use of portable firefighting equipment: fire extinguishers &amp; hoses).</p> <p>Red signs and physical closure by cones installed by the patroller were ignored by some drivers during the first phase of incident (some driving between the cones).</p> <p>Some drivers drove in reverse in order to get out.</p> <p>Some drivers occupied the emergency lane in front of tunnel entrance → Modifications of Traffic Regulations after the incident: more strict rules about the use of emergency lanes.</p>
<b>Emergency Services</b>	<p>Difficulties faced by the Emergency Services, due to the emergency lane being occupied upstream (was ignored &amp; blocked by drivers), due to congestion in front of tunnel entrance.</p>
<b>Tunnel Equipment &amp; Operation</b>	<p>The emergency stations into the tunnel were very well recognizable by the users. They made use of existing firefighting equipment (fire extinguishers and hoses) and of emergency telephone.</p> <p>Some difficulties were encountered in the initial phase of tunnel closure for implementation of blocking traffic vehicles (no barriers).</p> <p>In the absence of barriers, patrols are essential for quick tunnel closure in case of an accident → Procedures were adopted to secure the presence of patrols.</p> <p>Some modifications were adopted for equipment of the patrol personnel. Questions remain about legal obligation for personnel to proceed to firefighting before arrival of rescue services.</p>

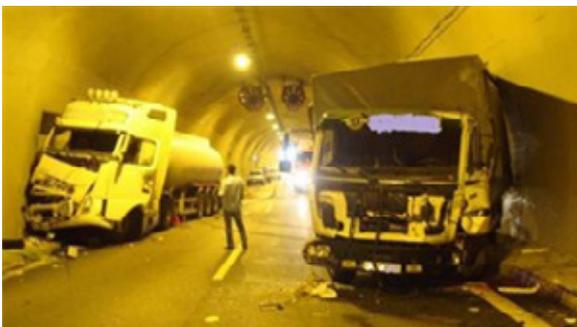
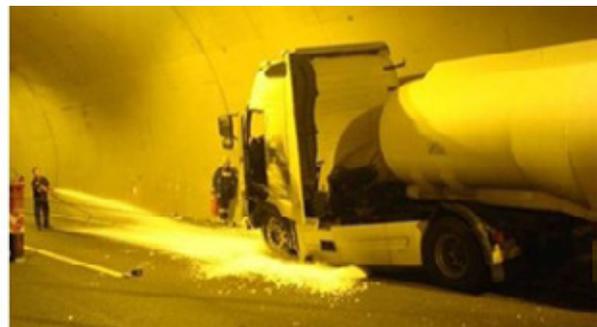
A semitrailer tanker (loaded with 25 T of gasoline and oil) that was on the closed right lane had a rear collision with the light truck. No fuel leakage, despite the impact on the tunnel sidewall.

<b>Human behaviour</b>	Tunnel is forbidden to DG vehicles, but some go through nevertheless. The driver of the tanker completely ignored the red crosses signs. During the first minutes, ongoing traffic was noted between the two immobilized trucks. Many drivers did not respect the traffic signs (VMS, LCS & red lights both at tunnel entrance & inside tunnel). Blocking of the tunnel was finally achieved when some professional drivers stopped at the portals, blocking the entrance → role of professional drivers seems to be critical (they can act as leaders). The vehicles trapped behind the immobilized vehicles escaped with a controlled turnover through the traffic cross passage to the other tube. Some drivers informed the Control Centre of the accident and of the smell of gasoline, accelerated the decision for tunnel closure.
<b>Emergency Services</b>	Fire brigade arrival time was long. Removal of the tanker was done very careful to avoid DG release.

<b>Tunnel Equipment &amp; Operation</b>	The Control Centre at first did not have a clear perception of the situation because the accident took place in a blind part (not covered by CCTV network). The ventilation system was manually activated (for precaution reasons). Non-compliance of many drivers to the signals → physical closure seems to be more efficient (no barriers at the time of accident).

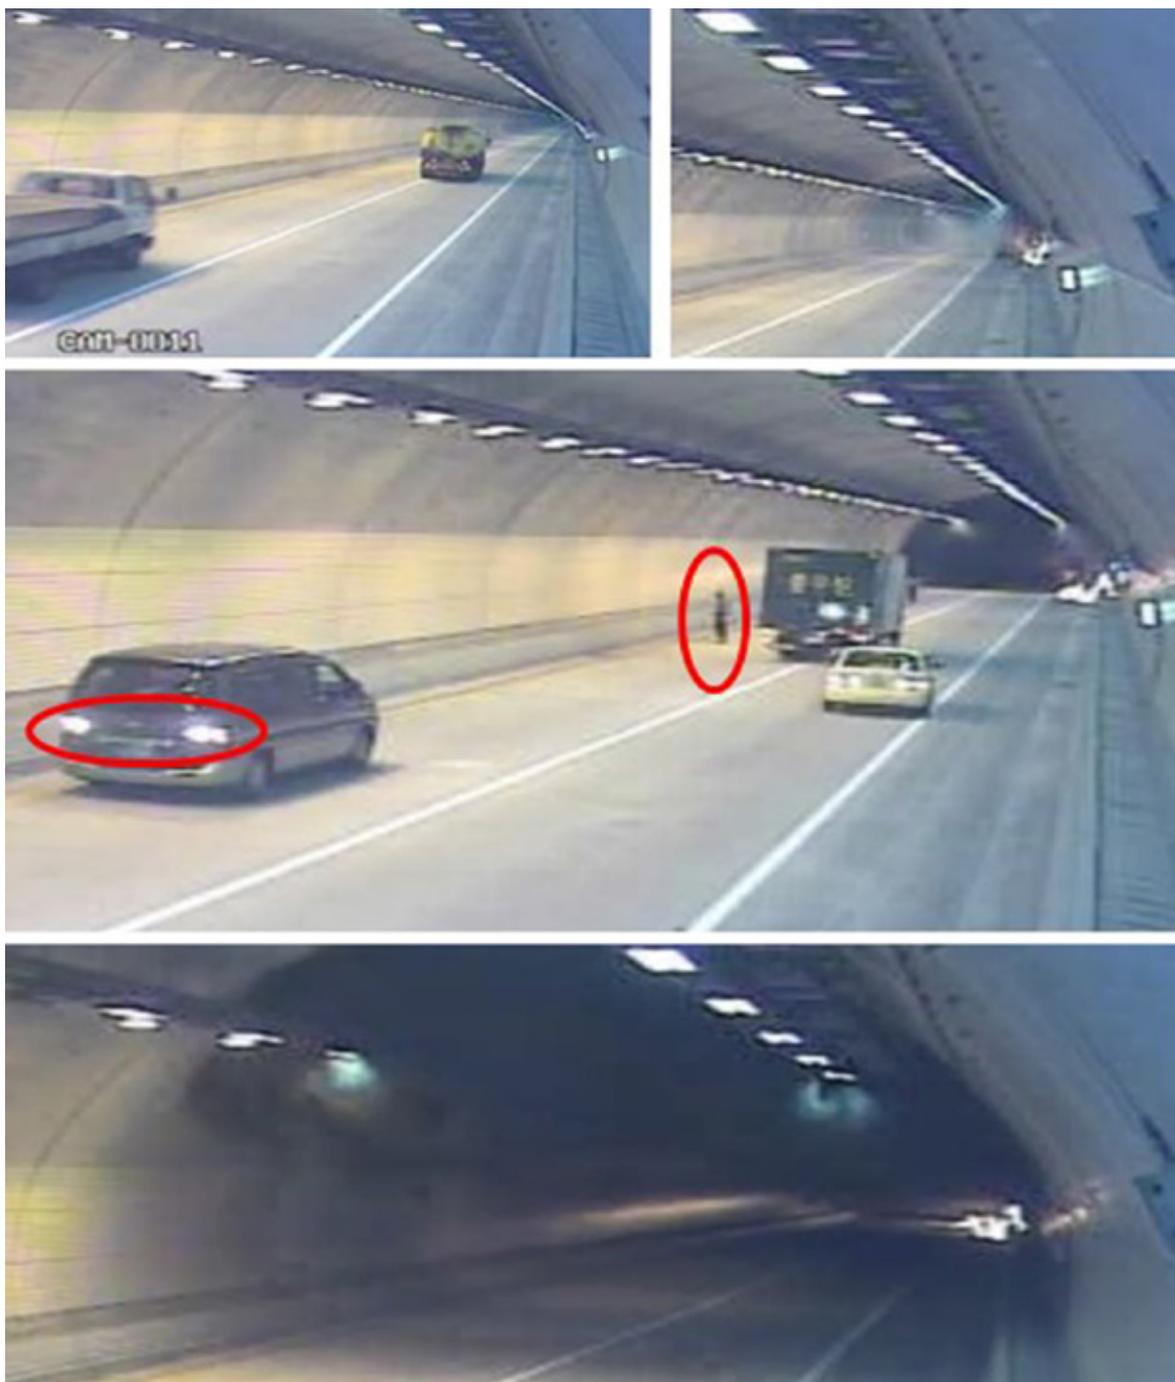
**Short description of incident:** In a 2 tubes motorway tunnel, a first light lorry drove from right lane to the left one, and then came back to the right lane. Consequently, a second light lorry carrying thinner (DG) that was behind on the left lane braked suddenly to avoid the first lorry: the driver lost control and crashed against the right side wall of the tunnel.

This collision immediately degenerated into a fire. The truck burnt completely, no casualty.

<b>Human behaviour</b>	A few vehicles entered after the collision, then stopped behind the lorry on fire. One person went outside his vehicle. Another driver reversed back. Nobody approached to see if the driver of the vehicle on fire needed help. After a while, all the vehicles reversed out. Driver of the lorry in fire walked downstream (longest way to the exit).
<b>Emergency Services</b>	Fire brigade arrived in 15 minutes. They suffered from heat and toxic gas.
<b>Tunnel Equipment &amp; Operation</b>	Due to the prompt and large size of fire, and because thinner fire spilled to the utility duct, the electricity cables were damaged which caused blackout and stopped all the facilities. After the fire, the tunnel authority took several measures such as: Add scenario and fire drill method for DG; Education for tunnel operator; Public relations to road users. Six jet fans were activated in less than 5 minutes by tunnel operator. VMS (Variable Message Sign), LCS (Lane Control System) and entrance shutting device were used. However, power supply system went down due to the damage of cables → Consequence on ventilation: backlayering was noted.

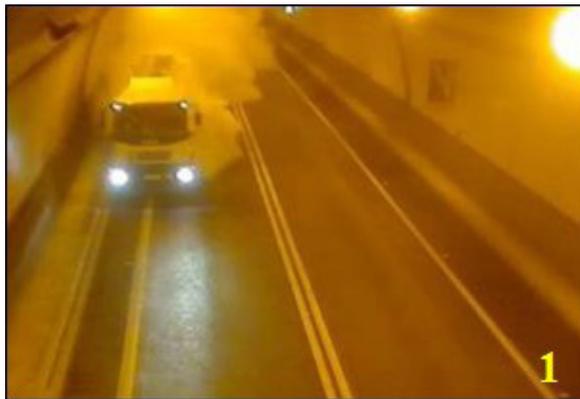
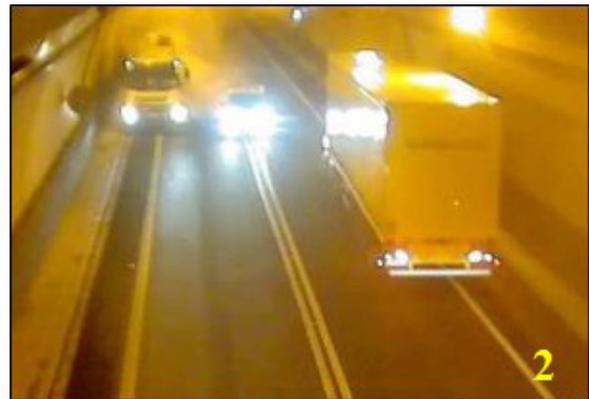
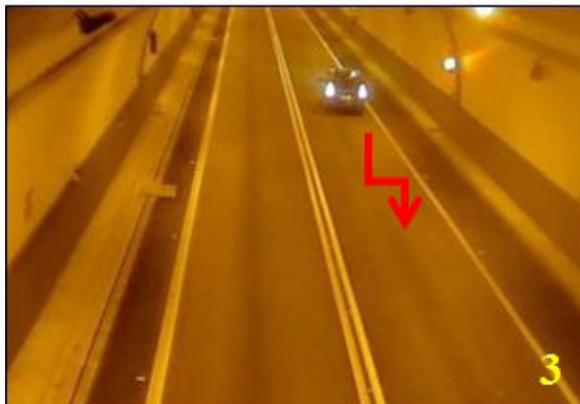
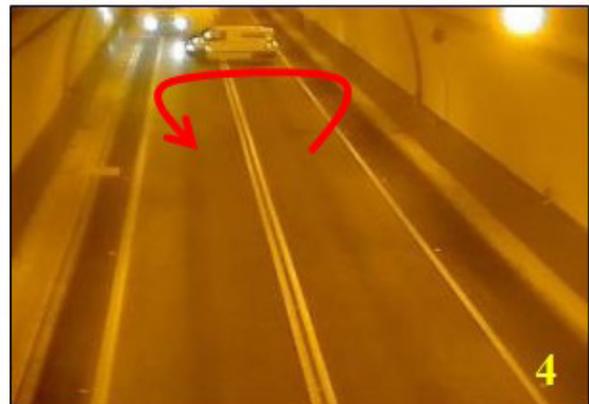
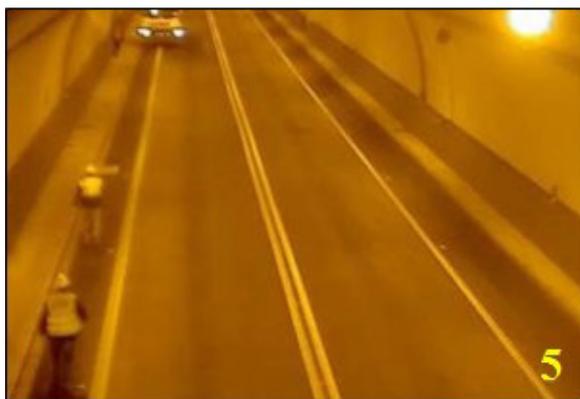
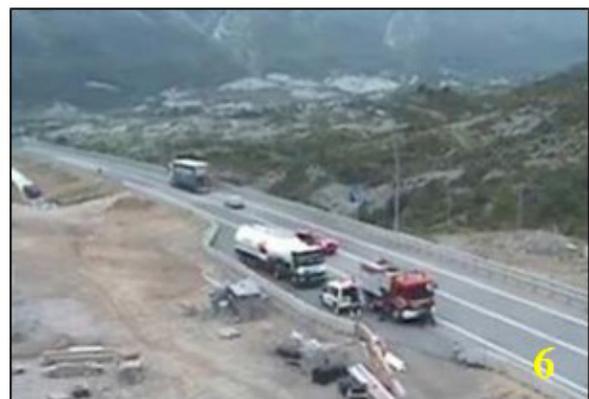
A DGV carrying 20,000 litres of fuel suffered a turbo compressor failure while it was circulating through the tunnel, generating a large amount of white smoke inside the tunnel (picture-1). The vehicle moved forward for 500 meters, until it finally stopped.

<b>Human behaviour</b>	<p>The DGV driver did not stop when smoke began to escape from the truck: he tried to drive outside. When he finally stopped, he did not leave the tunnel, remaining close to the truck. After a few minutes (not immediately), he decided to contact the Control Centre through an emergency station.</p> <p>All the vehicles that were in the tunnel at that moment passed the truck and did not stop to assist. Furthermore, some of them made forbidden movements such as overtaking (picture-2), driving backwards (picture-3) or U- turns (picture-4). Nobody used the emergency exists.</p>
<b>Tunnel Operation</b>	<p>Operator of control center detected immediately the incident and launched the incident response plan.</p> <p>Some of the workers who were working in the parallel tunnel went to the incident place, so as to see what happened, and remained close to the truck (picture-5).</p> <p>As a consequence, the Emergency Response Plan has been modified after the incident in order to improve coordination between the Operator and the company responsible for the refurbishing works in the parallel tunnel.</p>

<b>Emergency Services</b>	<p>The firefighting services arrived 20 minutes after commencement of the incident. At that time, the problem has already been solved (picture-6).</p>
<b>Tunnel Equipment</b>	<p>The south portal barrier did not work due to a mechanical failure.</p> <p>As a consequence, after the incident, it has been decided to increase the maintenance frequency of the systems which are not used frequently (like the closing barriers).</p>

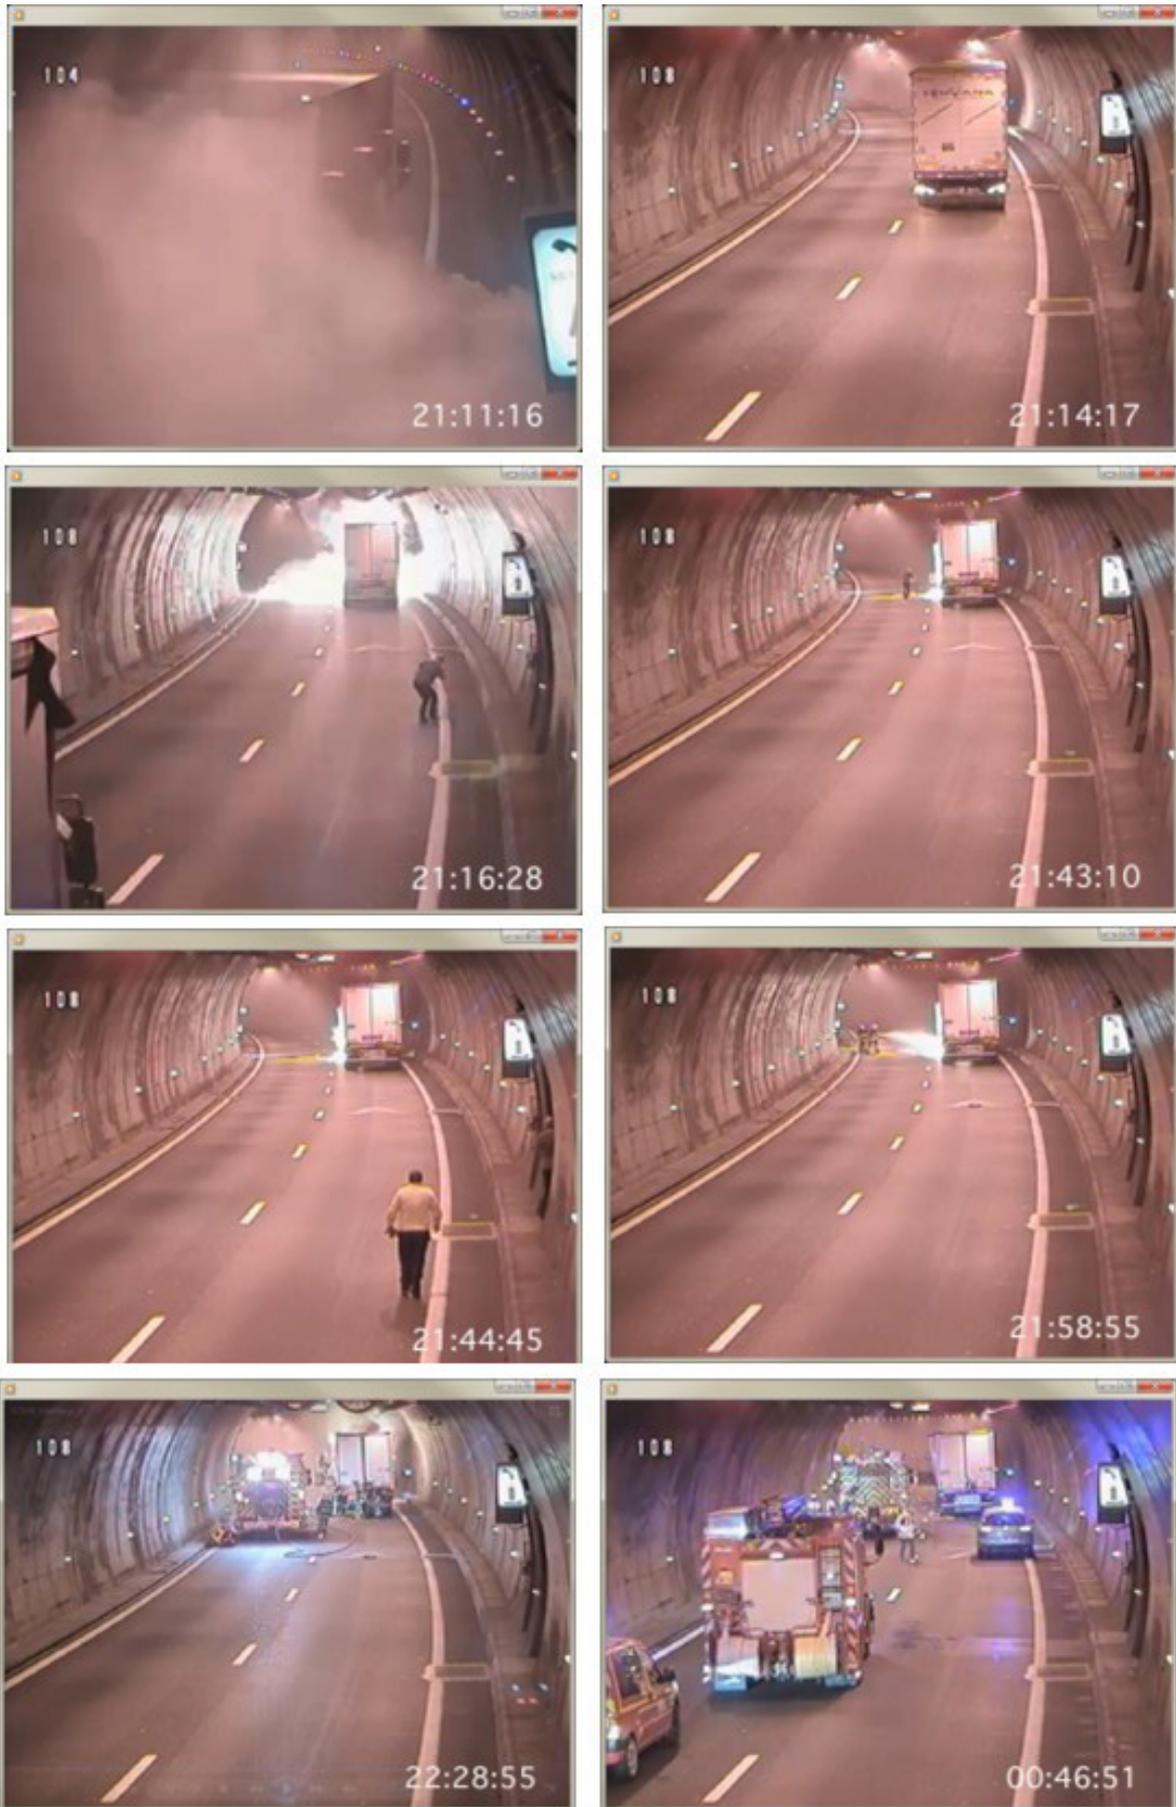
Relevant illustrations (19):

**Short description of incident:** In a 1.5 km long twin tubes motorway tunnel, a HGV caught fire & stopped due to technical problem (possible origin: turbo compressor failure).  
A second HGV stopped close to the HGV on fire.

<b>Human behaviour</b>	The driver of HGV on fire tried to fight fire with an extinguisher (the one in the cabin of the 2nd HGV), without success. After that, he called the control centre using an emergency telephone. Then he tried again to fight the fire with a fire extinguisher at disposal in the emergency station, again without success. He stopped trying to fight the fire when a tyre exploded. Then both drivers came in the HGV cabin of the 2nd HGV. They joined an emergency exit (by-pass) only when they were ordered to do so by the firemen (at their arrival on site). After having joined a by-pass, the driver of the HGV on fire came out of the by-pass twice to join the fire place, so that it had been necessary to ask him again and again to join and stay in the by-pass.
<b>Tunnel Operation</b>	Operation worked very well (delay to launch the fire sequence, ventilation, tunnel closure, etc.).

<b>Emergency Services</b>	Difficulties/lack of communication between the different intervention teams (firemen & police) → need for “ <i>connection officers</i> ”. Language problems with HGV drivers (they spoke no English nor the language of the country where the fire took place). It has been identified the necessity to update the Emergency response plans (communication improvements, language issue).
<b>Tunnel Equipment</b>	It has been impossible to connect to the fire hydrant in the affected tunnel tube (the hose has been connected from a hydrant in the non-affected tube; therefore the doors of the by-pass remained opened during the intervention) → The maintenance program has been updated in order to check with a better periodicity the all the fire hydrants.

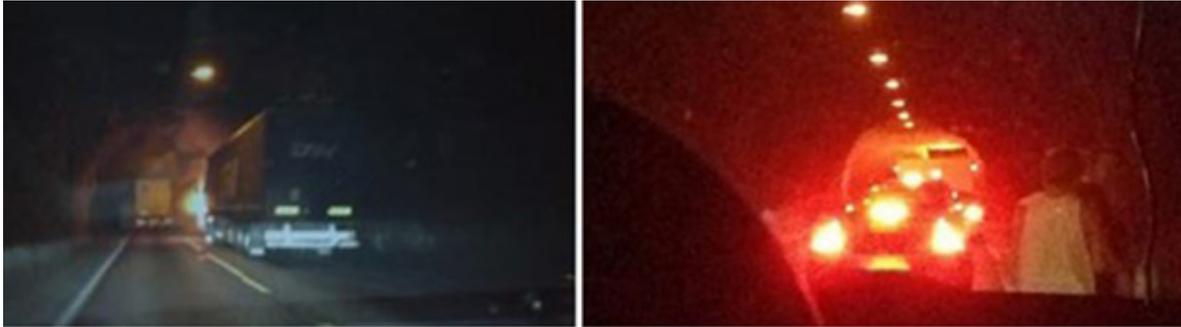
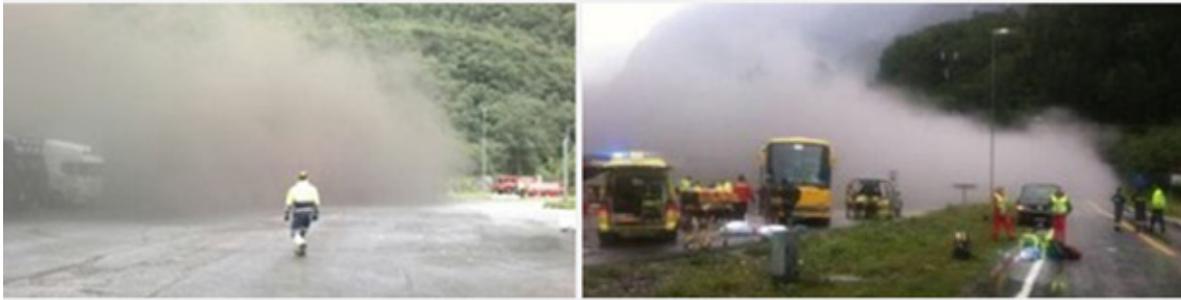
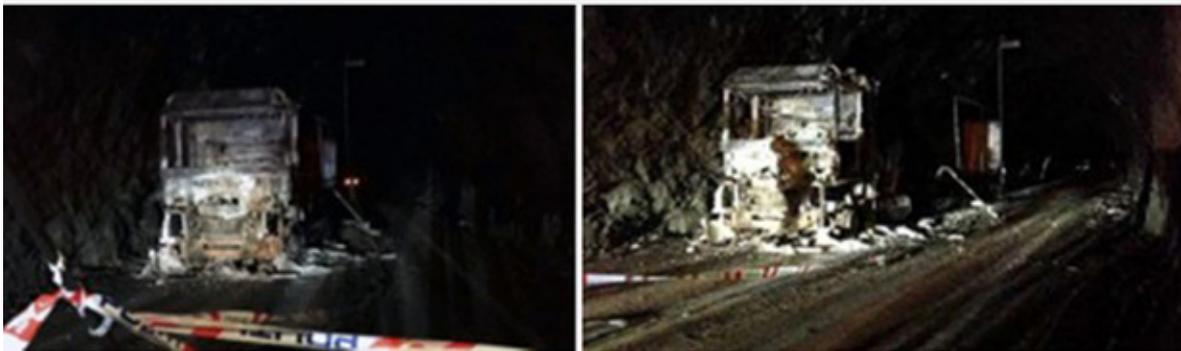
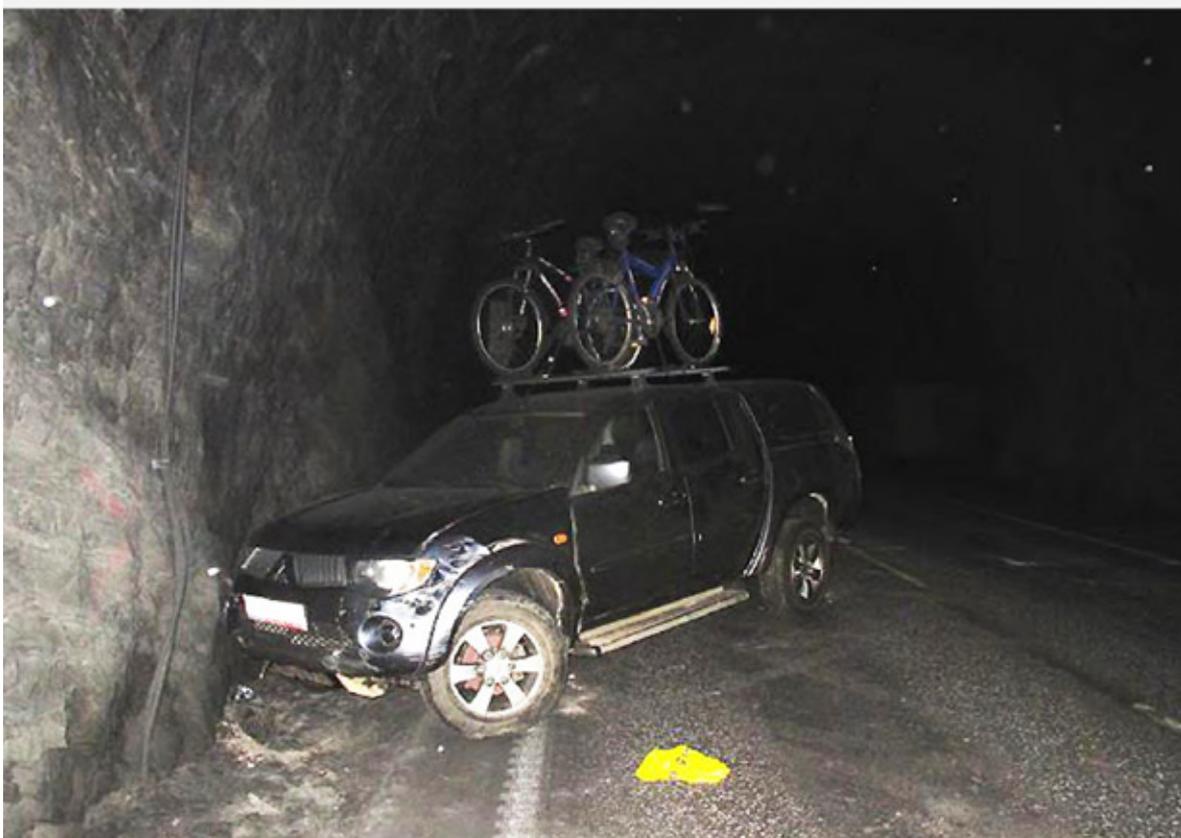
<b>Emergency Services</b>	<p>The tunnel was not equipped with any kind of monitoring or device for counting vehicles that could have provided continuous information about how many vehicles were in the tunnel. However, such devices are not mandatory equipment. The Road Traffic Centre and the fire service thereby did not have an overview of how many people were inside of the fire towards which the smoke was ventilated.</p> <p>According to the emergency response plan, the fire service, that was situated close to the eastern portal of the tunnel had the responsibility to react. On the western side of the tunnel the nearest fire service was over one hour away.</p> <p>The fire service arrived at the fire site 30 minutes after the fire was reported. The fire was extinguished within 30 minutes.</p>
<b>Tunnel Equipment</b>	<p>The tunnel is equipped with totally 92 fans, divided into 6 groups. Due to continuous maintenance 5 – 10 fans are normally out of service. This fact does not influence the necessary capacity of fire ventilation according to the emergency response plan for the tunnel.</p> <p>There are 18 lay-bys in the tunnel, illumination according to standard regulation, 20 SOS telephones, 42 fire extinguishers and communication cable through the tunnel.</p>

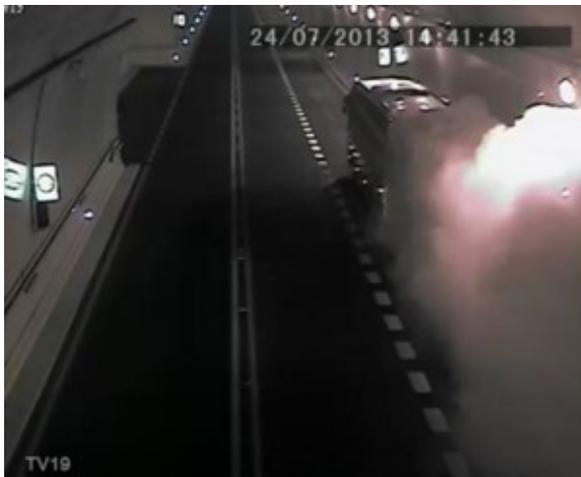
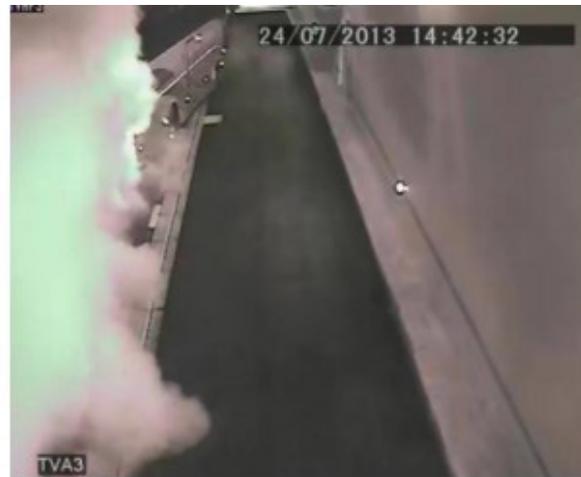
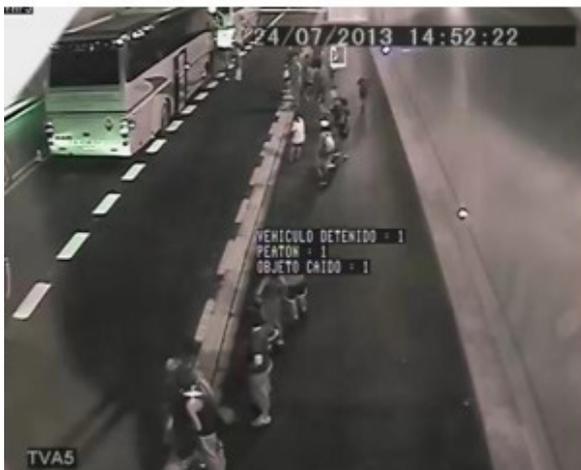
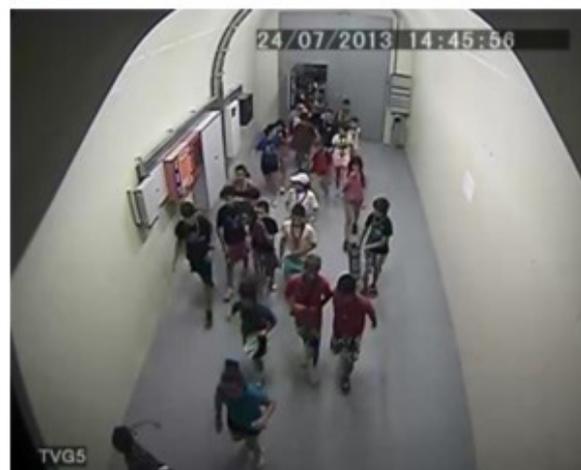
The day of the incident, a convoy of four buses entered the tunnel with about 150 passengers (most of them children). Due to an engine failure concerning one of the buses, a large amount of white smoke was suddenly generated. However, the bus did not stop, and continued moving along the tunnel until it arrived at a point where the barrier was down. As a result, three of the buses stopped in lay-bys, while the fourth one left the tunnel without problems. A vehicle which was moving in the opposite direction didn't respect the signs and continued moving towards the place where the buses were stopped. When it arrived to the place of the incident, it passed by the broken bus and got into the smoke. As the visibility level was extremely low, the driver turned round and stopped near the broken bus.

<p><b>Human behaviour</b></p>	<p>The driver of the bus that generated heavy smokes did not stop until it arrived in front of a barrier close to a lay-by. Then most of the people remained in the bus or close to the bus. Some of the bus passengers started to walk along the tunnel road, instead of going towards the nearest emergency exit.</p> <p>Moreover, a vehicle driver did not respect the stop signals of the tunnel. As a result, this driver has also been involved in the incident.</p> <p>People involved in this event did not know how to behave after the incident: the evacuation process began only when a staff member arrived and guided people. The importance of the presence of this staff member during the evacuation was noted. The necessary personnel that must be present at the local control centre in the future is now a question under study.</p>
<p><b>Tunnel Operation</b></p>	<p>Tunnel operation during the incident went according to the emergency procedures. Anyway, some mandatory calls from the local control centre of the tunnel to the main control centre of the region could have caused a delay when alerting emergency services.</p>

<p><b>Emergency Services</b></p>	<p>Emergency services arrived 20 minutes after the incident. The firefighting services that arrived to the West portal had no radio or phone signal so that they had some communication problems.</p> <p>As a result, some operative rules regarding emergency services have been changed after the incident: Now, in cases of an incident in the tunnel, emergency services arriving at the West entrance have to visit the control centre, prior to any action in the tunnel.</p>
<p><b>Tunnel Equipment</b></p>	<p>All the systems worked as expected. IR cameras were really useful to follow the evacuation process, whereas classic cameras have been disabled because of the smoke. Barriers inside the tunnel revealed to be a good device to stop the traffic.</p> <p>Barrier at east portal was damaged by the emergency services. Therefore, its visibility has been improved after the incident.</p> <p>Once the emergency services took control of the situation, they activated the 2nd stage of the ventilation system (smoke exhaust stage). It now under study if such decision could be taken directly by the operator under specific circumstances.</p>

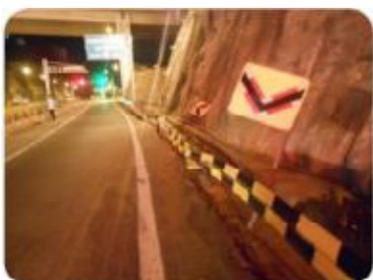
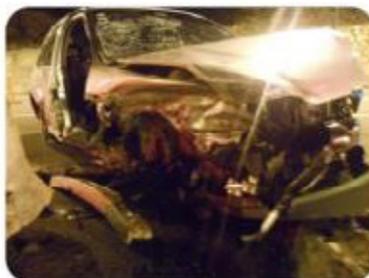
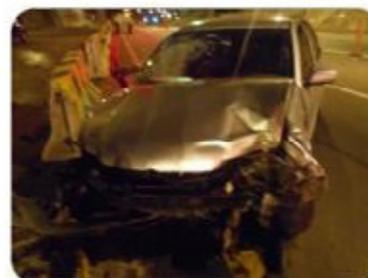
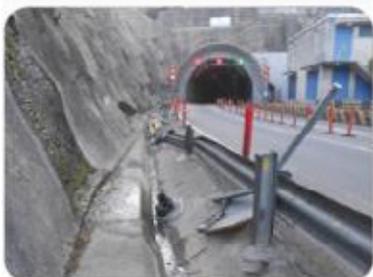
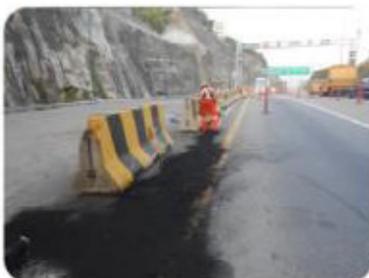
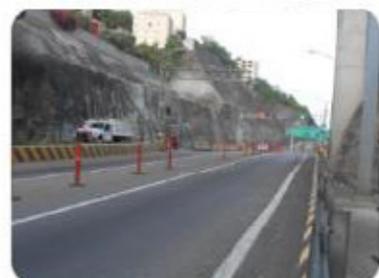
MAINS CONCLUSIONS	
<b>Human behaviour</b>	Drivers of other cars passed by. They respected the red lights and evacuated when needed.
<b>Tunnel Operation</b>	Cashiers on payment lanes are instructed to forbid access to the tunnel to drunk drivers. Video surveillance helps to identify drivers behaving unsafely (over-speeding, hazardous driving, etc.) so that the operator's staff are able to give them recommendations to prevent collisions.
<b>Emergency Services</b>	-
<b>Tunnel Equipment</b>	-

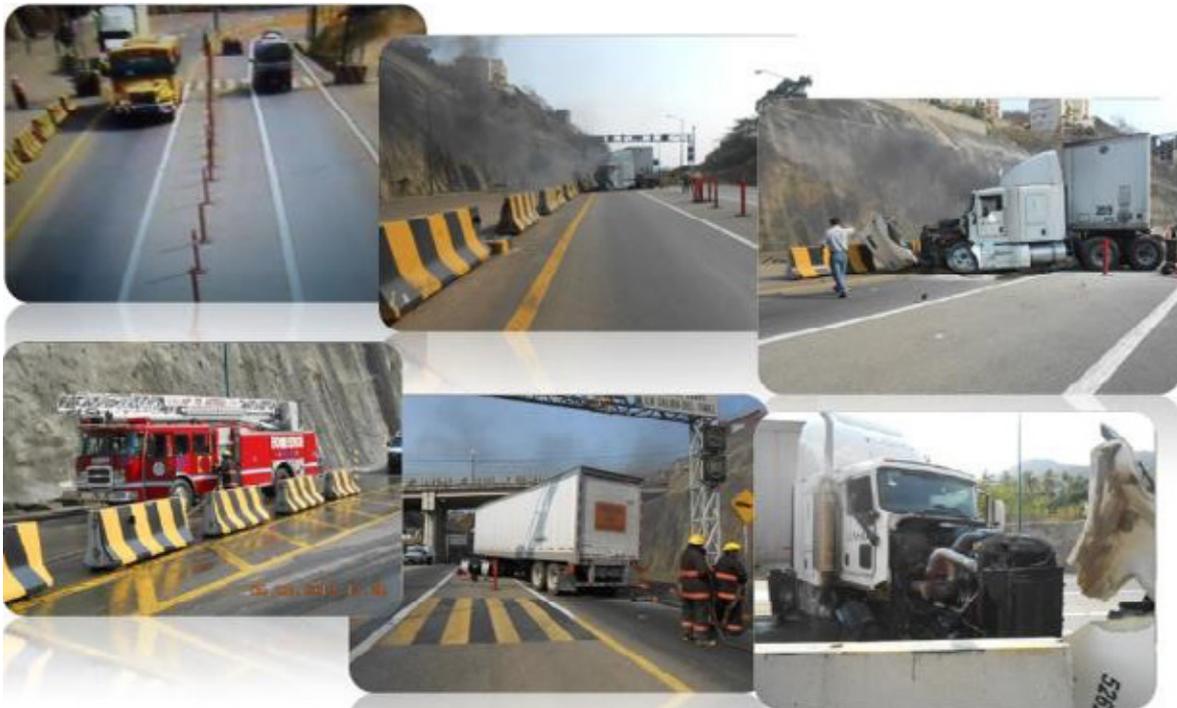
**Short description of incident:** On the approach of a 3 km long one bore toll tunnel with 3 lanes, a truck driver, driving too fast, did not see a lane reduction. Consequently, he lost control of his vehicle and hit a signal concrete base. Some diesel oil spilled and degenerated into a fire.

<b>Human behaviour</b>	HGV driver driving too fast.
<b>Tunnel Operation</b>	Maintenance team used fire extinguishers
<b>Emergency Services</b>	When firefighters arrived at scene, they took over from the maintenance team to contain and extinguish the fire. When police arrived at scene, policemen helped to stop the traffic.
<b>Tunnel Equipment</b>	The signals have been modified after the incident, for a better understanding of how to behave when drivers are approaching the scene.

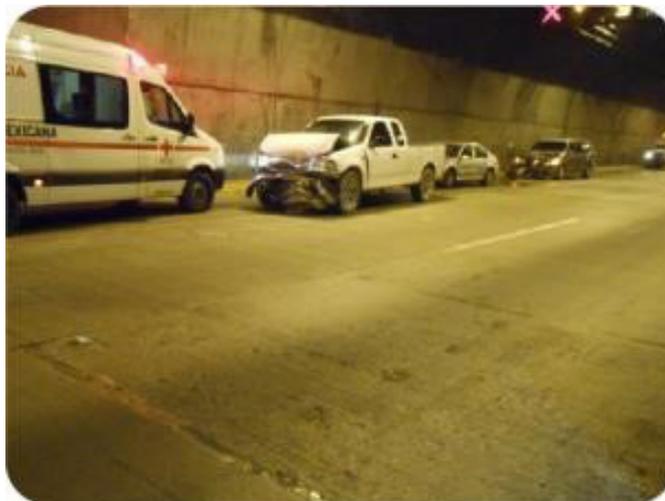
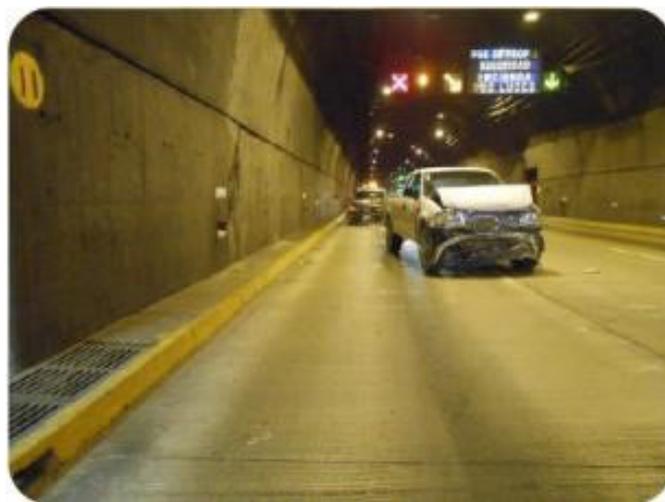
**Short description of incident:** In a 3 km long one bore toll tunnel with 3 lanes, a speeding vehicle hit a car ahead (low speed vehicle due to a mechanical failure). A 3rd vehicle behind was not able to stop and hit the speeding vehicle, resulting in 3 vehicles being damaged and slightly injuring the people.

MAINS CONCLUSIONS	
<b>Human behaviour</b>	Drivers of the affected cars remained in their vehicles. Drivers of other cars stopped to assist; drivers respected the red lights.
<b>Tunnel Operation</b>	Video surveillance helps to identify drivers behaving unsafely (over-speeding, hazardous driving, etc.) so that operator’s staff is able to give them recommendations to prevent accidents.
<b>Emergency Services</b>	-
<b>Tunnel Equipment</b>	-
