## APPENDIX 5 – referring to chapter 5 “Examples of interesting findings from real incident information”

### 5.1. EVALUATION OF QUESTIONNAIRES ON REAL TUNNEL INCIDENTS – SURVEY OF 32 REAL TUNNEL INCIDENTS

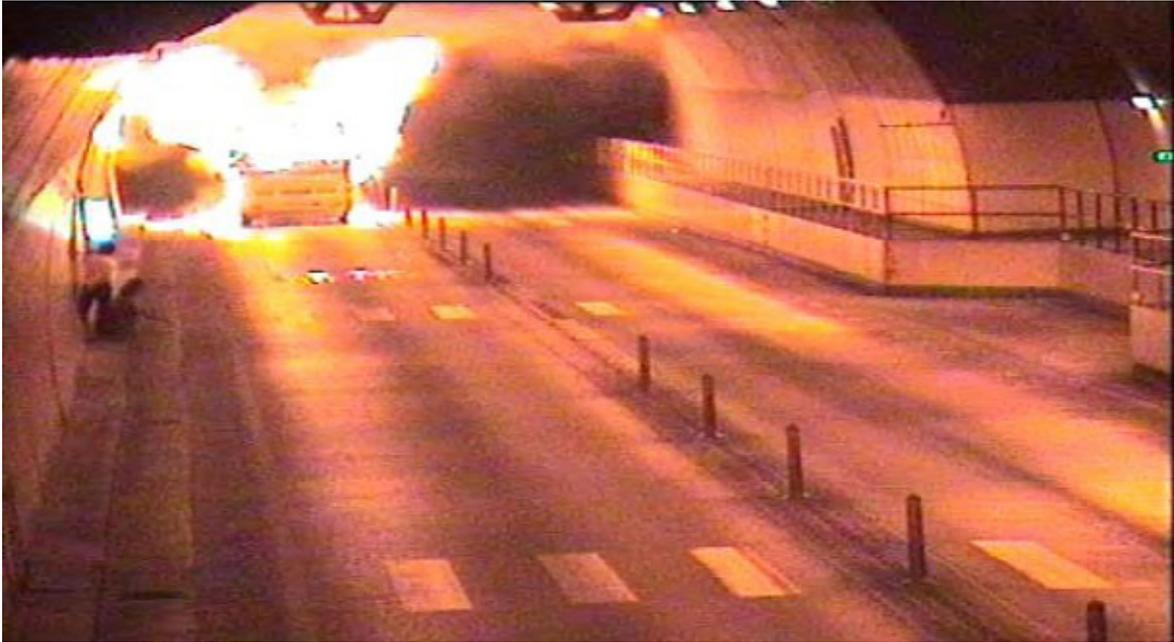
**Short description of incident:** In a 6.2 km long bidirectional single bore traffic and adjacent evacuation tunnel, a coach caught fire and stopped in the tunnel. The coach driver went to the front of the coach and made a call on SOS Phone. The fire was detected by Operators using CCTV and linear heat detection. On site, fire rescue teams were mobilised and in attendance in less than 6 minutes. Fire was extinguished before it reached its full potential. People were evacuated into the evacuation tunnel. There are no reported injured people as a result of the incident.

MAINS CONCLUSIONS	
<b>Human behaviour</b>	Many poorly maintained vehicles are in use, and many overloaded goods vehicles are seen. Road traffic violations are unfortunately very common.
<b>Tunnel Operation</b>	<p>Tunnel is monitored 24 hours per day allowing a rapid response to an incident. In case of a fire, the operation mode is as follows:</p> <ul style="list-style-type: none"> <li>• Fire is detected from CCTV or from the rate of rise addressable linear heat detection system which shows the tunnel zone of the fire;</li> <li>• The operator selects the ventilation fire plan for that zone, and the system is configured to automatically control the air flow to achieve zero velocity in the zone of the fire;</li> <li>• The operator closes the tunnel portals and sets intermediate traffic lights inside the tunnel to prevent traffic approaching the fire zone; at the same time mobilises the onsite Fire Team and on site Rescue Team.</li> <li>• When the rescue team confirms to the Operator that one side of the fire is clear of people, the ventilation is put into longitudinal mode in the direction of the side of the fire cleared of tunnel users so as to assist firefighting operations;</li> <li>• After the incident, an onsite scene clearance team clears the tunnel of damaged vehicles and prepares the tunnel for reopening, whilst system and tunnel integrity is checked by tunnel engineers.</li> </ul> <p>After the incident, the tunnel Operator has refined procedures so as to achieve the fastest possible response to tunnel fires by the onsite fire team.</p>

<b>Tunnel Equipment</b>	<p>A jet fan system is used for ventilation in a fire situation. The jet fan system is fully reversible and uses a control philosophy to create a zero velocity in tunnel zone where the fire is situated. The zero velocity theoretically enables maximum stratification of the smoke to allow tunnel users to escape via cross passage doors into the parallel evacuation tunnel.</p> <p>After the incident:</p> <ul style="list-style-type: none"> <li>• New illuminated evacuation signage has been provided in the main tunnel aNew illuminated evacuation signage has been provided in the main tunnel and evacuation tunnel, in order to improve effective evacuation of people;</li> <li>• CCTV surveillance and control room displays have been improved, with planned links to Provincial Police control room to improve the control &amp; identification of traffic violations;</li> <li>• Improved SCADA and Traffic Management Control computers have been provided;</li> <li>• Further investment is planned to improve the efficiency of the tunnel ventilation system.</li> </ul>

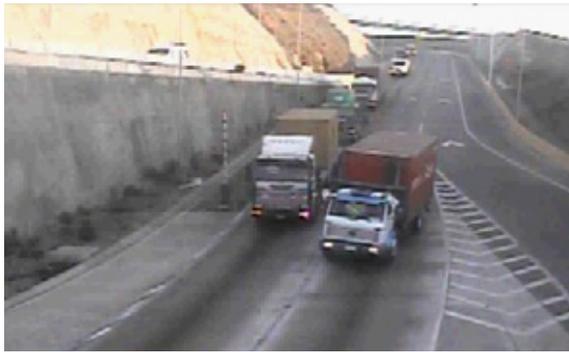
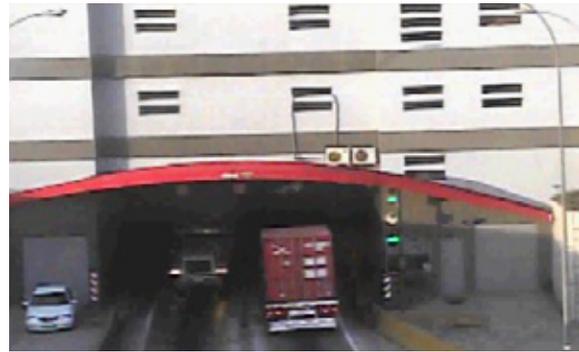
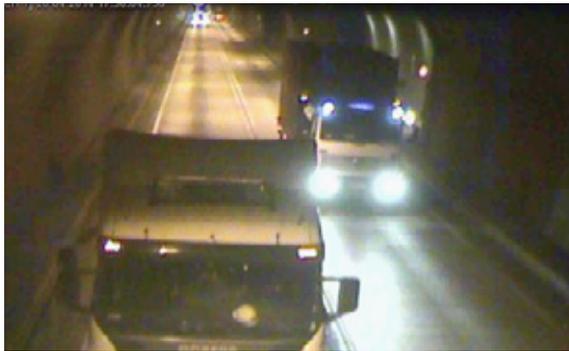
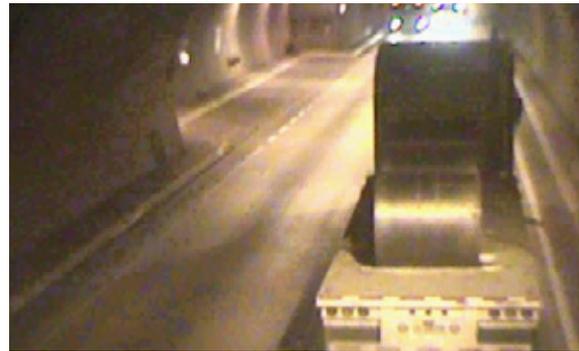
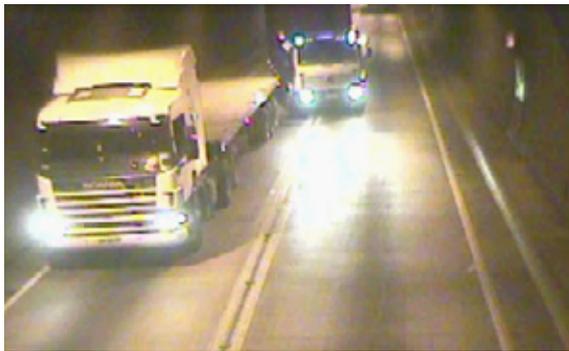
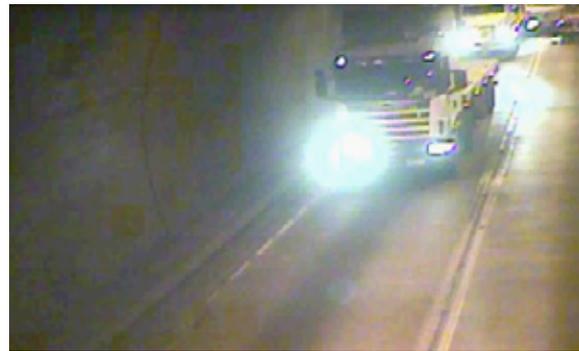
**Short description of incident:** A HGV driving fast on the road is detected through the Closed Circuit TV. The HGV is overtaking other vehicles on its way to the tunnel. The HGV enters the tunnel at high speed, without braking (due to brakes failure), and overtaking vehicles when possible. 1.8km after the tunnel entrance, this fast HGV collides with a second (unloaded) truck while overtaking it, causing a fuel release. A second collision occurs with another HGV coming from the opposite direction. The HGV that provoked the collisions eventually comes to standstill between the other two involved HGVs.

<b>Human behaviour</b>	<p>The driver of the HGV driving without brakes should have attempted to stop on an emergency lane before entering the tunnel (there are 5 emergency lanes along the 9km of road before the tunnel).</p> <p>There was no fire from the collisions. The driver of the HGV that caused the collision was the only person injured (not severely).</p> <p>The drivers of the vehicles in the tunnel, close to the incident, stopped to help.</p>
<b>Tunnel Operation</b>	<p>The tunnel operator detected the incident through the Automatic Incident Detection (AID) system, and sent staff on site.</p> <p>The operator in the control centre called the emergency services (ambulances, fire brigades and police), harbour terminals and the Control Centre of the Logistic Support Extended Area of the harbour, which is 10 km distance from the tunnel, in order to stop the HGV traffic. He also launched alerts about the incident through the Variable Message Signs on the road, and closed the tunnel.</p> <p>Serious traffic disturbances resulted from the incident.</p>

<b>Emergency Services</b>	<p>Fire brigades and health services arrived on site 10 minutes after the incident, and police arrived 60 minutes later.</p>
<b>Tunnel Equipment</b>	<p>No damages on tunnel structure nor to the equipment resulted from the incident.</p> <p>The tunnel was reopened 5 hours after the incident.</p>

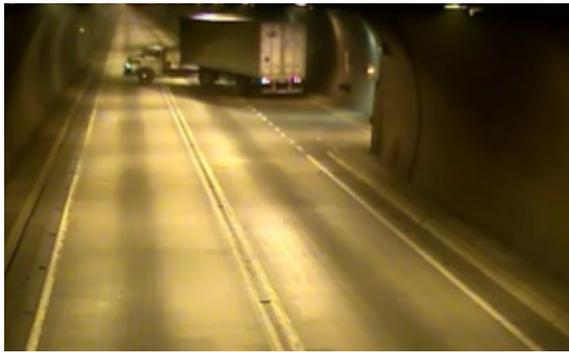
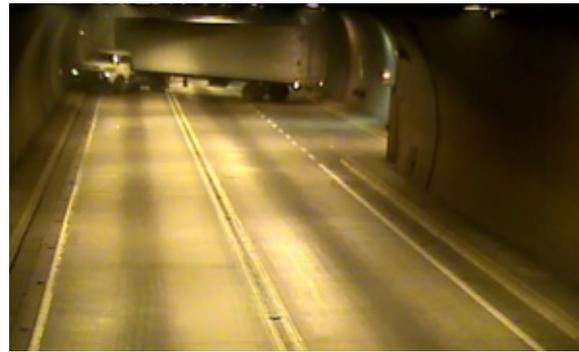
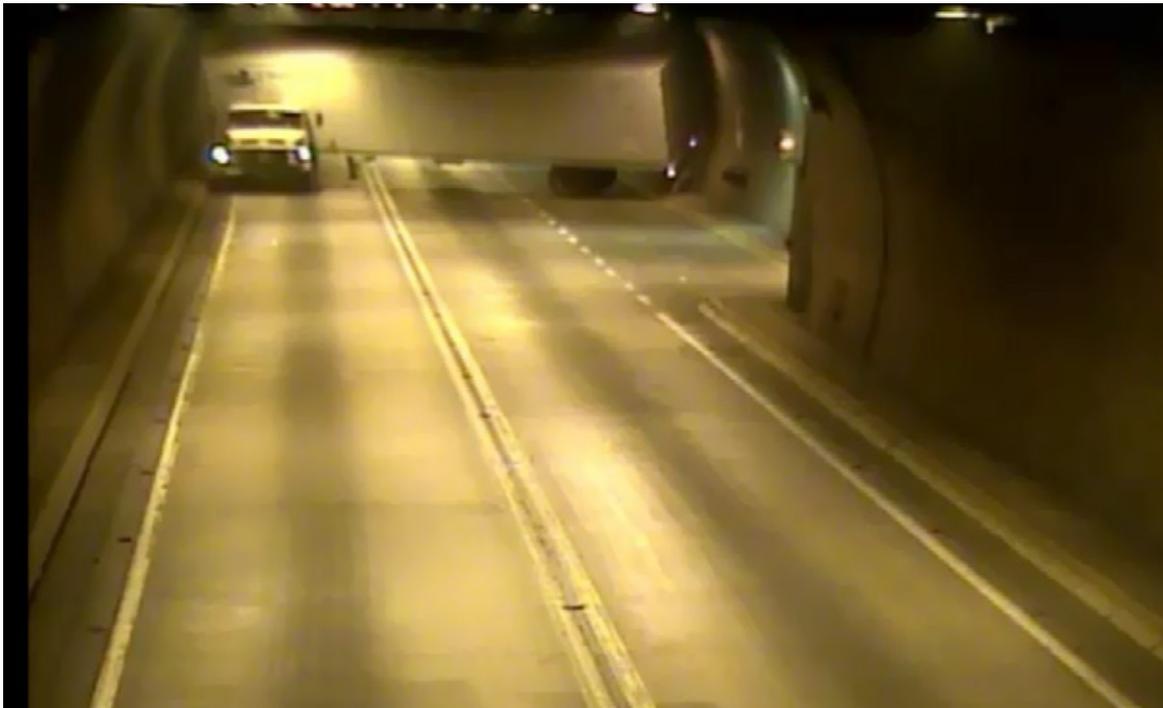
**Short description of incident:** The driver of a HGV tried to make a U-turn in a single bore bidirectional tunnel. He finally got stuck on both sidewalls during the manoeuvre. During the manoeuvre of the HGV, the shock absorbers of the right back wheel were damaged.

<b>Emergency Services</b>	The Police attend the incident and issued the offender with in fringement notice. No other emergency service was required. The tunnel operator telephoned the Control Centre of the Logistic Support Extended Area of the harbour, which is located 10 km from the tunnel, in order to stop the HGV traffic.
<b>Tunnel Equipment</b>	The tunnel equipment worked as expected: in particular, the Automatic Detection System warned the operator about the incident. There was no damage to the tunnel structure nor to the equipment resulting from the incident.
